Shear Behavior of Reinforced Concrete Beams Using Alternative Shear Reinforcement Technique

A Thesis Submitted to Council of College of Engineering, the University
of Diyala in Partial Fulfillment of the Requirements for the Degree of
Master of Science in Structural Engineering

Asmaa Shaker Mahmood

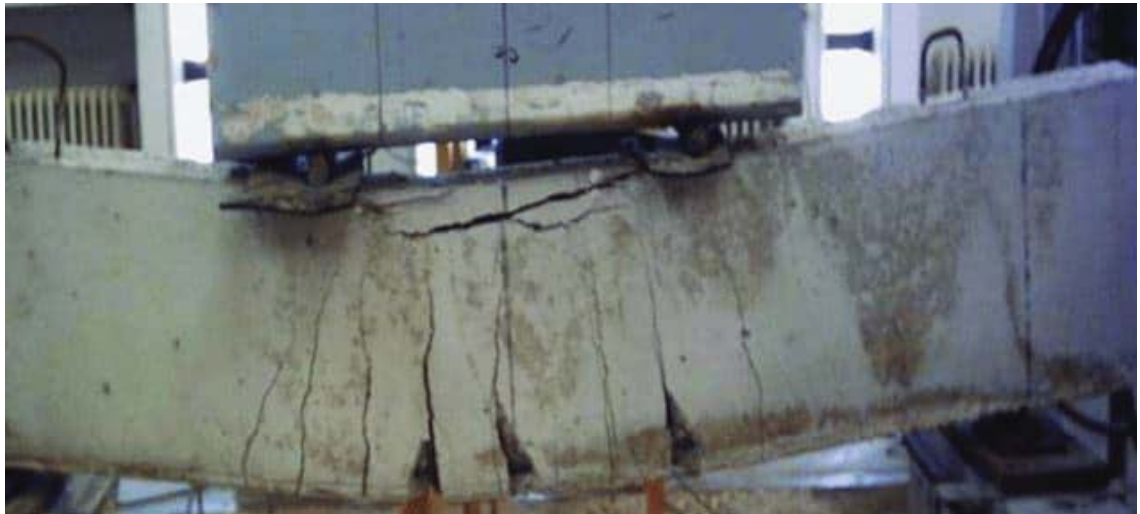
Plate (1-1) Beam Breakage Due to Flexure (Madeh Izat 2020)

the beam that is crushed after the steel reinforcement fails under flexural stress. According to ACI 318-19, this problem manifests itself when the reinforcement ratio of the beam is lower than the balanced reinforced ratio. There also needs to be a look backwards to find options that will help strengthen the shear and strike a good balance between the concrete beam's various functions. shown plate (1-1)

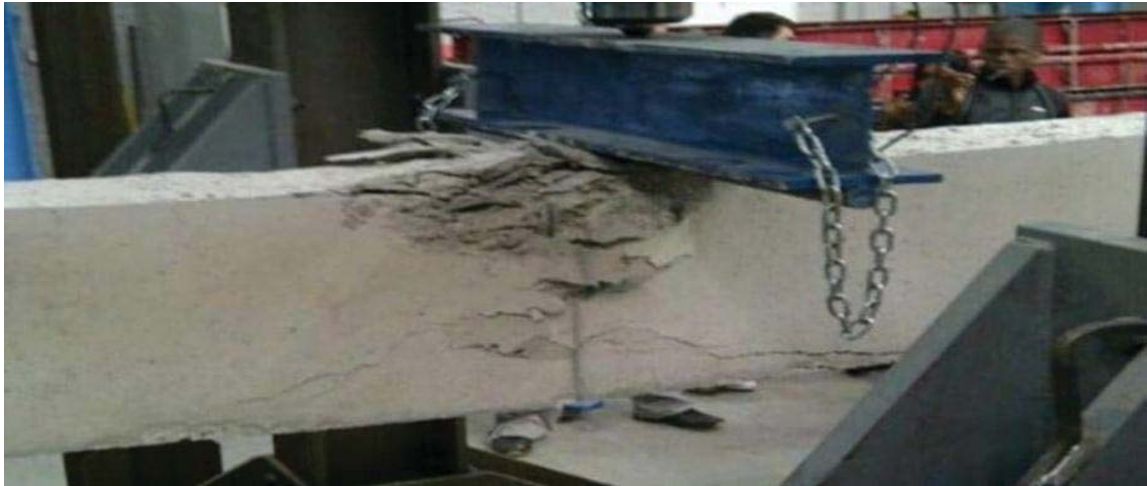
Plate (1-2) Cracking Due to Flexural Compression (Izat 2020)

In the event of a breakdown of flexural compression failure, the concrete on the compression side of the beam will give way before the steel on the tension side of the beam does. Beams have this issue when their reinforcement ratio is greater than the balanced reinforcement ratio, as specified by ACI 318-19. A brittle failure describes this type of sudden breakdown. Therefore, from the perspective of reinforced concrete, it is not suitable, as shown in Plate (1-2).
